Technical Service Bulletin from Electromotive on TECgt200, XDI200 and TECs200

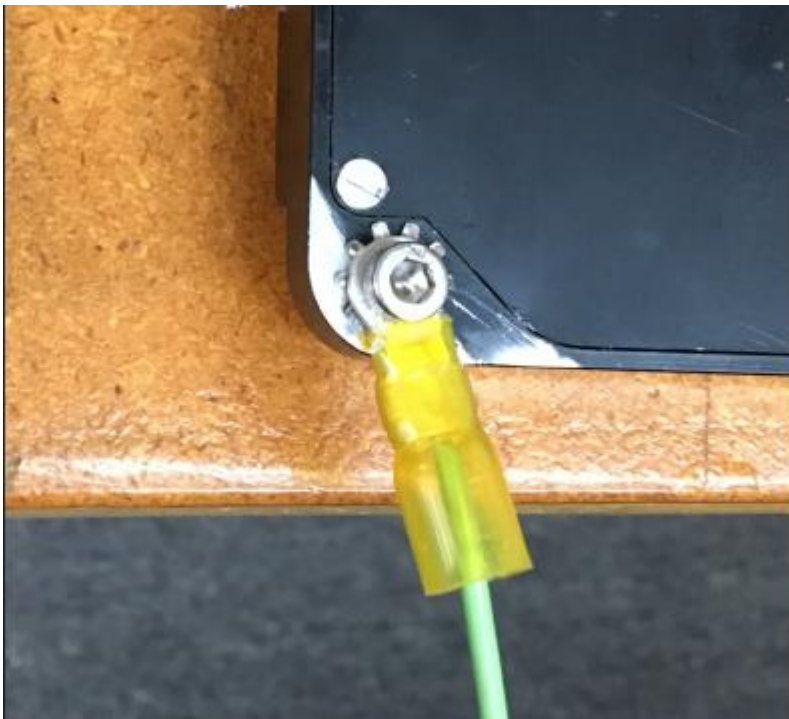
We have discovered an issue with the grounding of the aluminum chassis of the TECgt200, XDI200 and TECs200. The thickness of the anodizing and presence of anodizing in some threaded screw holes is preventing the metal chassis to be properly internally grounded. This results in excessive noise on analog inputs and possibly poor magnetic crank sensor triggering.

To correct the issue on your vehicle, you can add an external ground strap from the TEC's chassis to the point that you connect the main (large 12 gauge black wire) to your vehicle ground. As aluminum anodizing is an electrical insulator, you must scrape or sand away some of the black anodizing around the point where you attach a ground wire ring terminal. The attached picture shows the ring terminal on the back of the unit so that it is not visible after you apply the ground strap.

A ring terminal and 16 gauge wire should be sufficient to provide this ground. We suggest using a star washer to make a good electrical connection. Connect it to the common point where the main power ground of the TECgt200 is attached.
